Composite repair for aeronautical structures

Keywords: Composite repair, Abrasive Water Jet machining, finite elements models

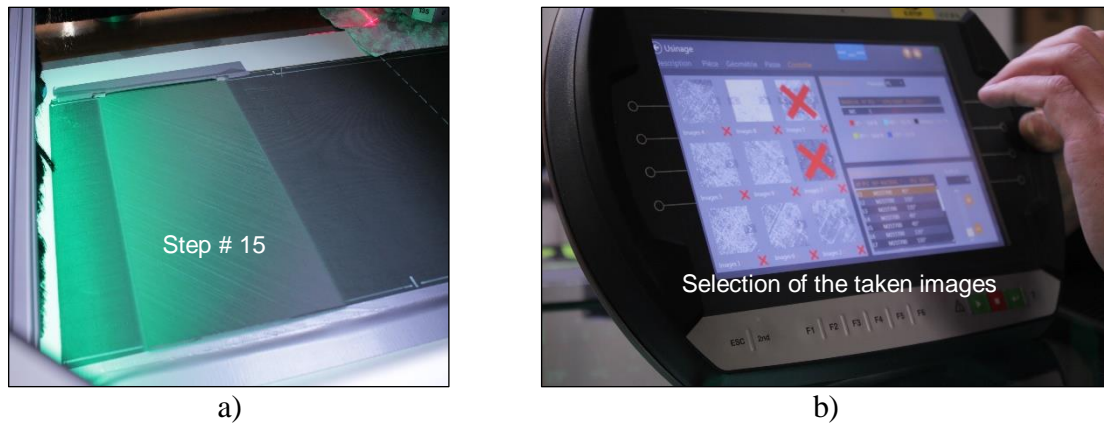
Once the machining process in one ply is finished, a verification is done by means of image analysis using the camera installed on the AWJ machine and a lighting of the machined zone through a set of four low-angled lights aiming in the four possible orientations of the reinforcement, 0° , 90° , $+45^\circ$ and -45° (cf. Figure 5a). To verify the fibre direction of the below ply, the camera takes four different images using each lighting angle. Indeed, the lightning emitted by the low-angled light is diffracted differently depending on the angle with respect to the long fibre orientation. The control unit compares the recorded images pixel-by-pixel. For accurate information, a selection of images from the screen of the control panel (cf. Figure 5b) shows an estimation of the matrix ratio in an interface between two plies and is evaluated to ensure that just one ply was removed. This is an alternative to direct measurement of the cut depth.

Figure 5. Verification process of the machining surface with a) overlap lap analysed by image analysis and b) visualization and selection of the taken images on the control panel to estimate whether or not the interface is reached.

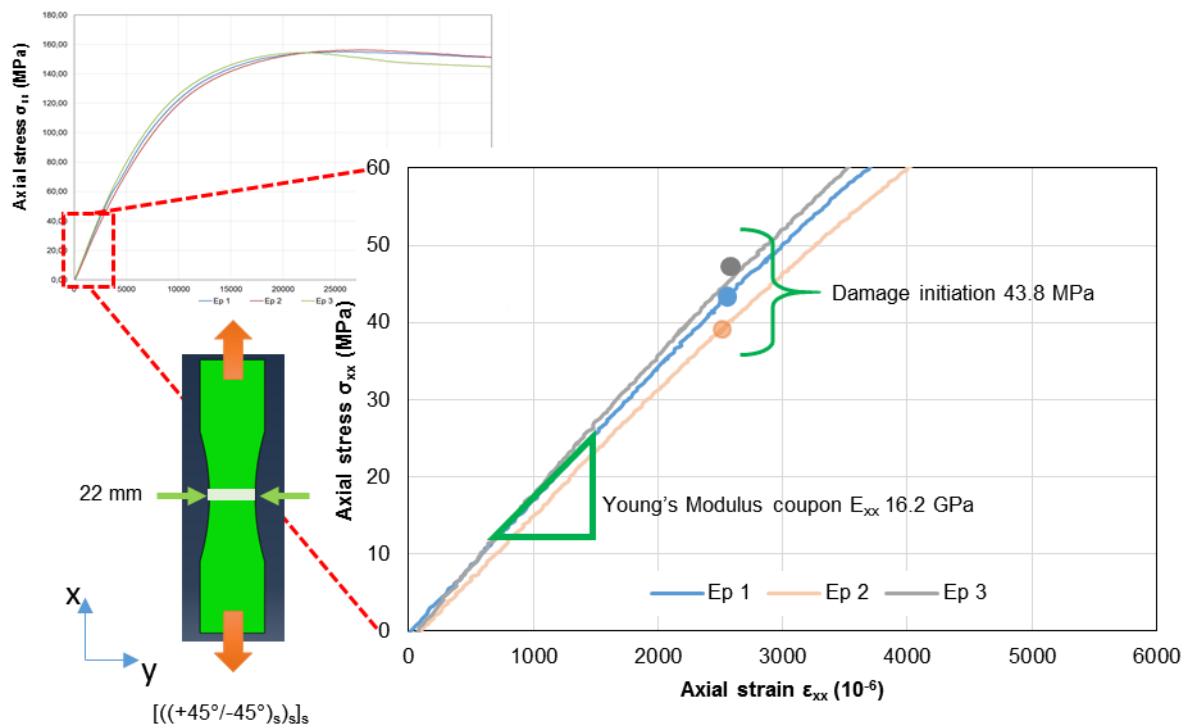
The input material data are identified through an inverse method. Indeed, there are some adjustments to be done compared to the values given by the manufacturer due to the real state of the matrix and the test configuration. For that, an unrepaired specimen is extracted from a non-repaired zone of the 16 plies $\pm 45^\circ$ plates. These testing coupons, noted Ep 1, Ep 2 and Ep 3, are shaped in the form of a dumbbell (with wider end tabs and a narrow gauge area) in order to control the place where the testing coupon is expected to nucleate the first damage, (i.e. away from the clamps of the universal test machine). The beginning of the nonlinear part of the axial stress-strain curve (cf. Figure 16) serves to the inverse analysis leading to the elastic and limit values of shear strength and transverse strength matrix identifications (cf. Table 2 and Table 3).

Figure 16. Inverse identification of the material properties (first damage initiation) using a tensile test on unrepaired specimens extracted from the mother plate.

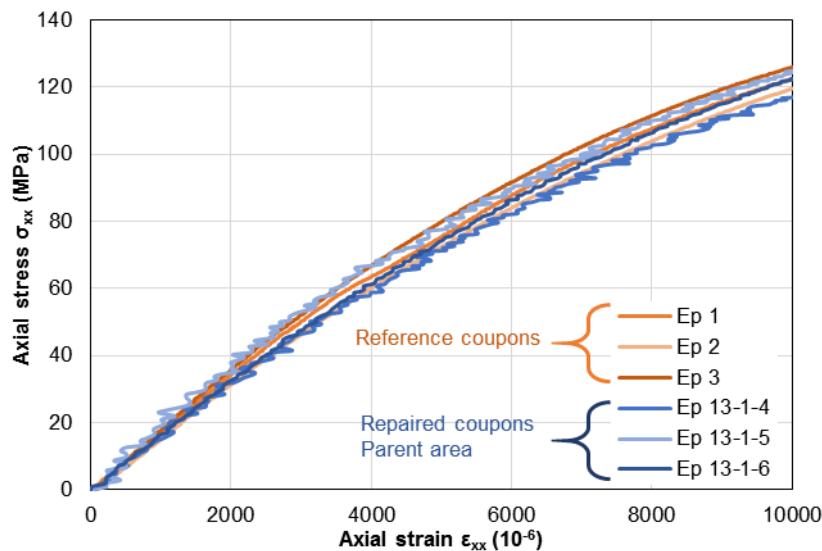
Comparing the test between the composite repaired specimens and the reference coupons, we cannot see any distinction in the mechanical behaviour (cf. Figure 18). At this moment of the test, the adhesive has not been damaged. Table 4 and Table 5 summarize the experimental results for the reference, non-repaired coupons, and the repaired coupons for the non-repaired parent area. We observe that the values for the Young's modulus, as well as the damage initiation limit are within the same order of magnitude.

Figure 18. Axial stress σ_{xx} – strain ϵ_{xx} curve of the parent area of the repair coupons 13-1, 13-2 and 13-3 and the reference test coupons Ep 1, 2 and 3.
